R.O.  
9-9  
3-17-88  
**Design and Evaluation of  
High Contract Ratio Gearing**

**Harold K. Frint**

*Sikorsky Aircraft  
Division of United Technologies Corporation  
Stratford, Connecticut*

**July 1986**

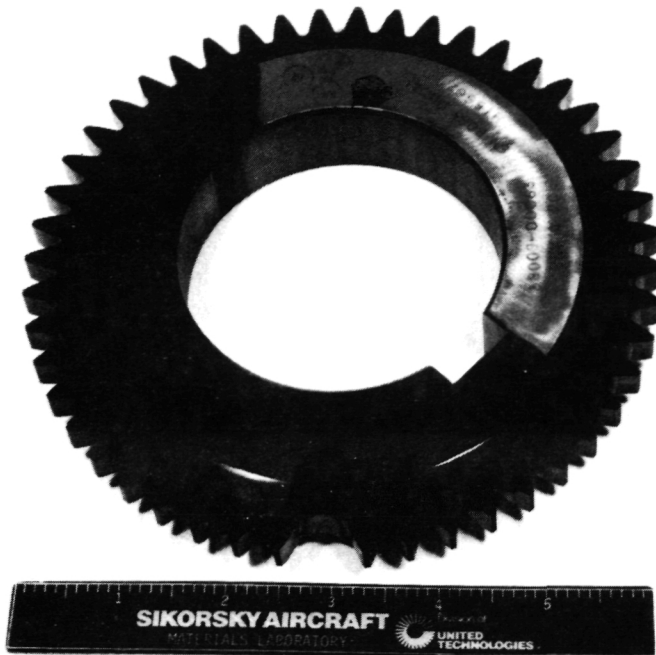
Figure 19. Test Gear Failures, S/N B063-00021

View A H.C.R. Gear 38009-00063  
S/N B063-00021.

View B Fracture Surface

View C Fatigue origin at edge of chamfer.

The high contact ratio gear S/N B063-00021 exhibited a single tooth fracture that was due to fatigue cracking which originated in the root fillet at the edge of the chamfer; Figure 19, views A-C. S/N B063-0044 did not contain any broken teeth. Scoring and spalling damage similar to that shown in Figure 17 was evident on most teeth.

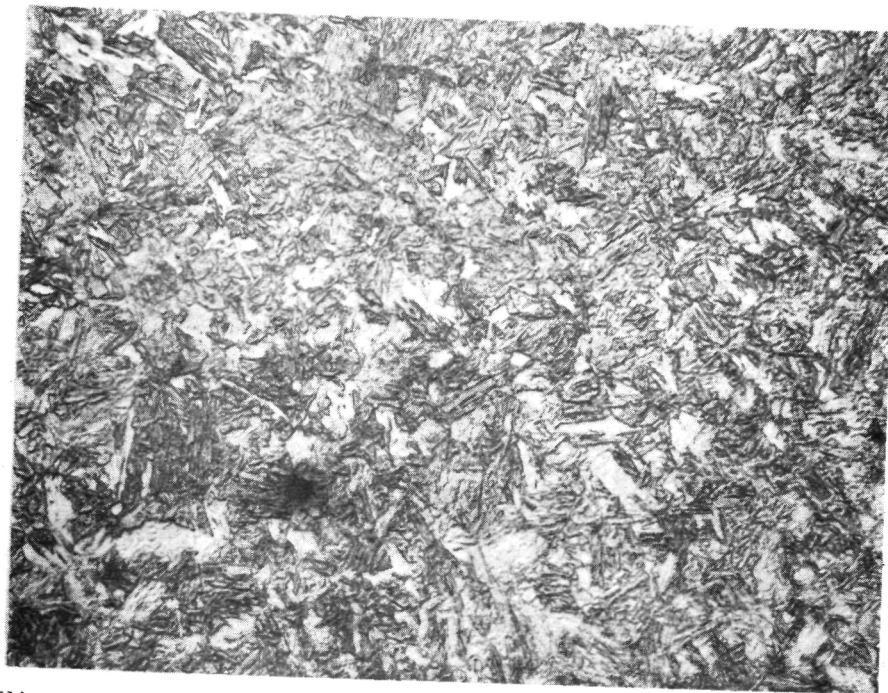
Figure 20. Test Gear Microstructure, S/N B063-00044

Case microstructure.

View B Core microstructure. Gear S/N 44 - typical  
for H.T. 6662.

Two heat treat lots had been used to carburize and harden the parts. Metallographic inspection revealed acceptable case and core microstructures for both lots, shown typically in Figures 20 and 21. Hardness of the case and core and case depths of the test gears are listed in Table 7.

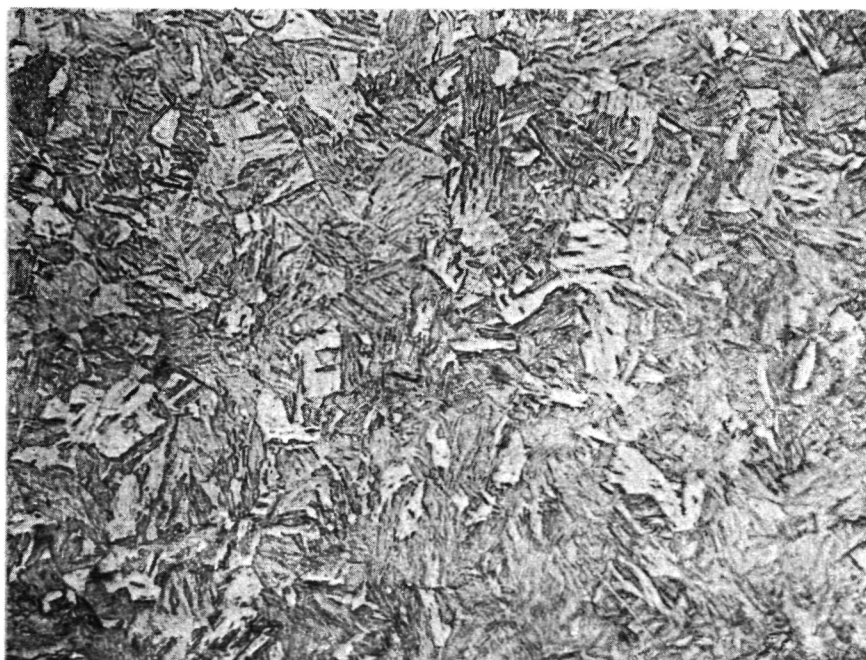
Figure 21. Test Gear Microstructure, S/N B105-00018

Case microstructure

View B Core microstructure. Gear S/N B105-00018.  
Typical of heat-treat 6631.
